5.3.1 Special Procedures for Plugged Nozzles

5.4 Evaluation of Grouting Operations

5.6 Destructive Examination of the In Situ Grouting Pit

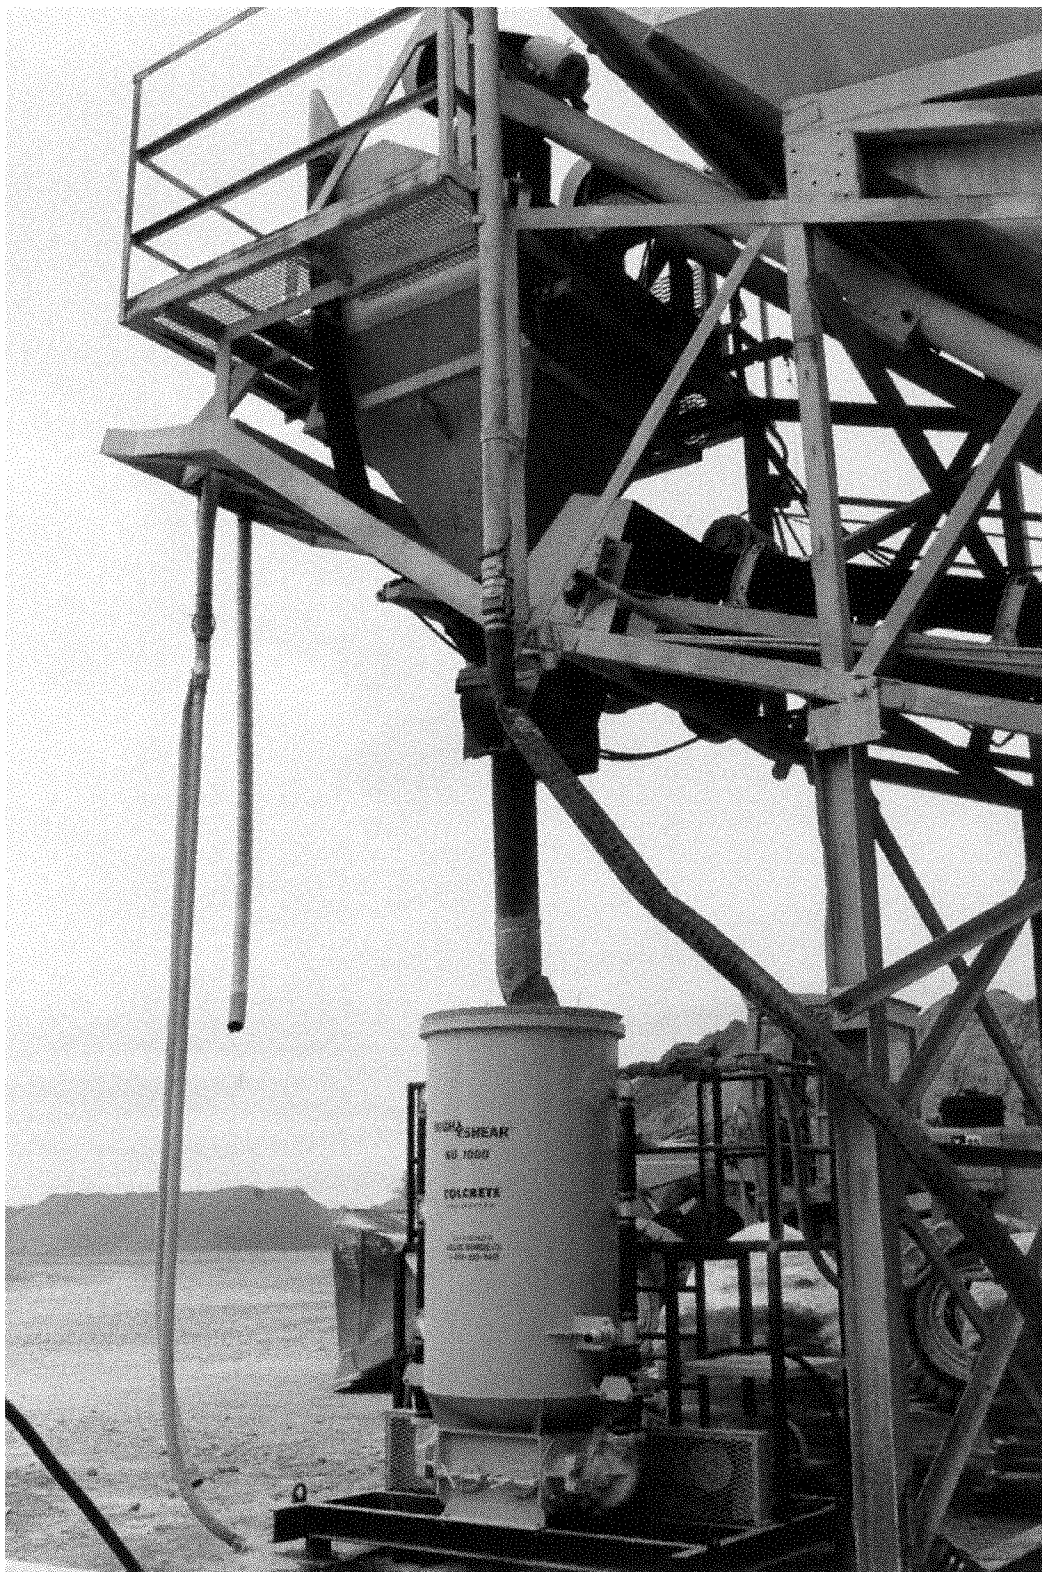
Figure 46. Batch mixing operation (Photo PN01-0520-8-9A).

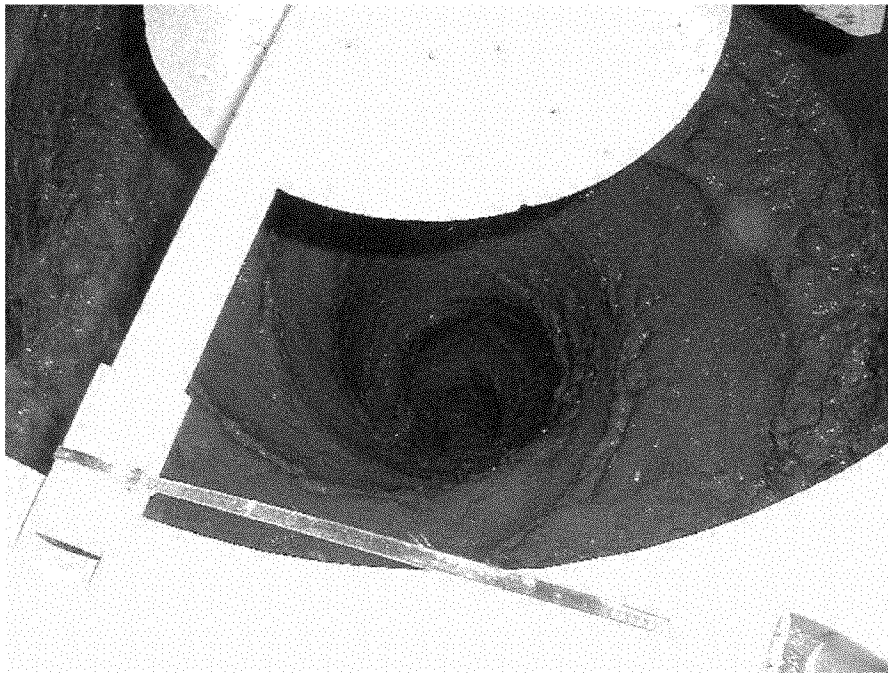
Figure 47. Grout mixer vortex view after 60 seconds of mixing.

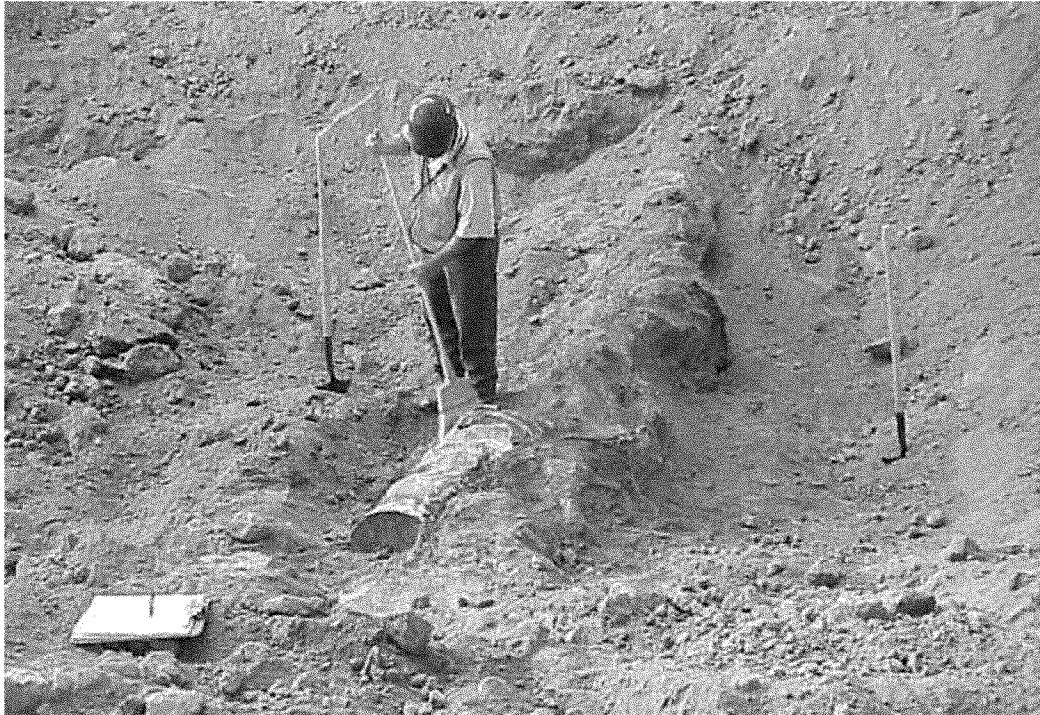
Using a backhoe with thumb attachment, the limited in situ grouting monolith (October 2002) was excavated, revealing a solid monolith with the usual inclusions of compacted clay soil. The shape of the monolith followed the shape of the holes grouted, which extended across the 4.5 m (15 ft) of the pit with the width of the monolith generally varying between 40-66 cm (16-26 in.) wide with the exception of the Northwest end of the pit. At this position a metal sided drum was embedded in a monolith and the width was 92 cm (36 in.) including drum and monolith. Based on records obtained during construction of the pit, this drum was determined to be a painted white metal-sided drum containing nitrate salts. The drum embedded in the monolith is shown in Figure 48.

Figure 48. Top of monolith showing grouted drum embedded in northwest edge.

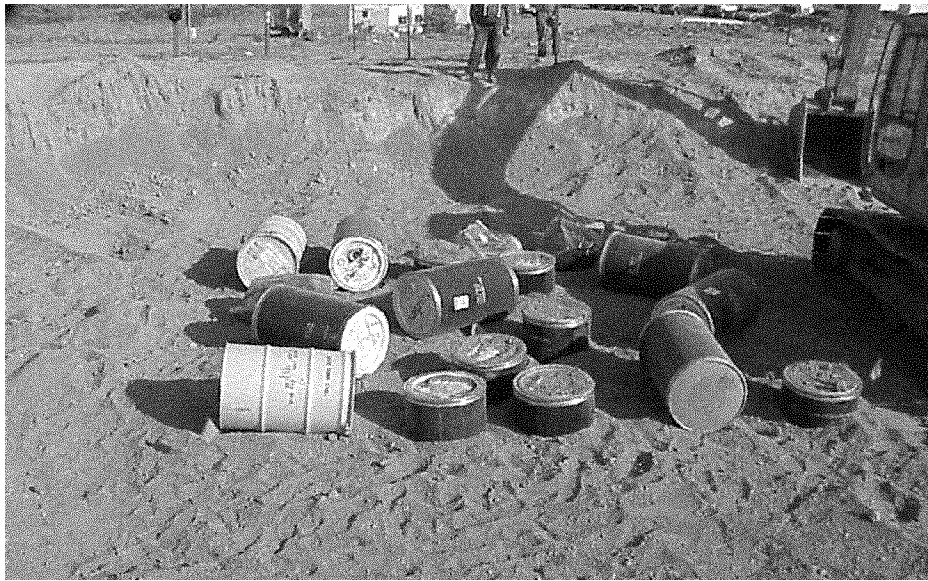
The section exposed was just the top of an 8-ft monolith of grouted waste and represented only grouting in 12 holes (approximately 2 rows of 6 holes each row). To the backhoe operator, the monolith was obvious in that there was a large resistance to digging compared to the surrounding soils. Figure 48 shows the top of the top of the monolith. Figure 49 shows the same region during construction of the pit with the white metal sided nitrate drum in the left corner.

Figure 49. Top layer of in situ grouting pit during construction with white nitrate drum in corner.
